## RAILWAY INVESTIGATION REPORT

R02D0069

### MAIN TRACK DERAILMENT

CANADIAN NATIONAL  
FREIGHT TRAIN M-353-21-02  
MILE 117.68, JOLIETTE SUBDIVISION  
L'ASSOMPTION, QUEBEC  
03 JULY 2002

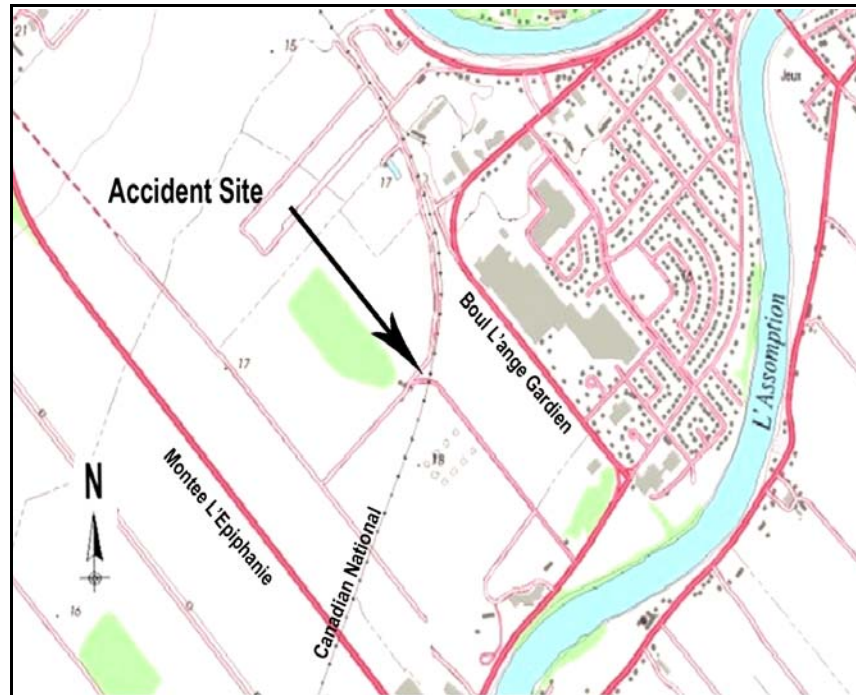
Figure 1. Accident site

The derailment occurred in a 2-degree right-hand curve, on a 0.1 per cent descending grade in the direction of travel (see Figure 1). Approximately 100 feet north of the private crossing, located at Mile 117.69, wheel marks were visible on the track structure (ties and ballast). Over a distance of 600 feet north of the wheel marks, on the west side of the track, the ties were skewed and the south rail anchors had moved up to two inches from the ties. There were no signs of rail creep on the east side.

Rail creep and tie skewing present north of the derailment zone were indicative of rail-stress redistribution and a modification of the rail neutral temperature in the area where the derailment occurred. Moreover, on the day of the derailment, the high ambient air temperature and the direct rays of the sun caused the rail temperature to rise, reaching levels unsurpassed since the major surface work had been performed in 1997-1998. Consequently, the temperature gradient (i.e. the difference between the neutral temperature of the rail and the rail temperature) and the compressive thermal stresses in the rail were abnormally high. It is probable that the additional compressive stresses caused by the rolling friction of the wheels and the loading and unloading of the track by the passing train axles triggered the buckling mechanism. The track then progressively shifted out of alignment under the train. With each passing car, the alignment deviation increased until the track shifted sharply and buckled. The 74<sup>th</sup> car could not negotiate the misaligned track and derailed.

1. Thermal stresses due to higher than normal ambient temperatures, combined with the forces exerted by the passing train axles, triggered the track buckling mechanism.
2. The train derailed when the 74<sup>th</sup> car could not negotiate the misaligned track.

1. CN has purchased three portable rail stress detection units, called VERSE, for undertaking spot checks of rail stress in CWR territories. These have been issued to the CN field forces that are undertaking frequent spot checks targeting suspicious locations. The introduction of these systems will aid maintenance employees in identifying the level of stress in CWR and reduce the risks of track buckle.

2. SPCs were amended so that extreme heat inspections are triggered when the ambient temperature exceeds 30°C (86°F). In addition, hot weather speed restrictions are imposed at known problem areas or where warning signs of track buckling are apparent.

3. CN contracted environmental services from a weather provider. With this new initiative, should the temperature exceed 30°C (86°F), a warning will be issued to the CN Traffic Control Centres, the CN Weather Monitor Web site and the e-mail bulletin board site. This information is then relayed to the appropriate track forces. In addition, the Engineering Network Operation Officers monitor the Weather Monitor Web site and will contact either the General Superintendent of Engineering or the Track Supervisors, to ensure that they are aware of the warning and the need to implement hot weather inspections and possible speed restrictions.
